Subject: Department of Natural Resources Washington Geological Survey,  
School Seismic Safety Assessments Project Phase 2, Contract No. AE 430 -  
Seismic Evaluation for **Spokane**

## **School Buildings Evaluated in the Spokane School District**

1. Bancroft (The Community School), Main Building
2. Bryant Center, Main Building
3. Havermale (Montessori), Main Building 1928 and 1940 Areas
4. Havermale (Montessori), Main Building 1928 Gym
5. Havermale (Montessori), Main Building 1965 Areas
6. Madison Elementary School, Main Building

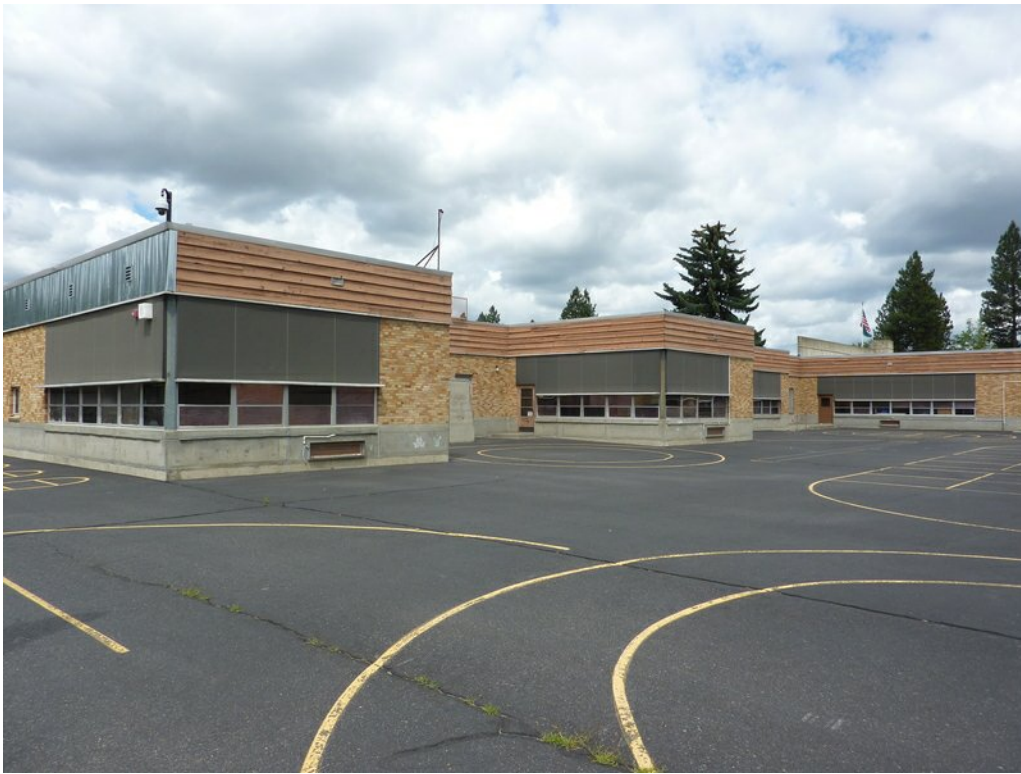
**Figure 1-5. South and east faces of west wing.**

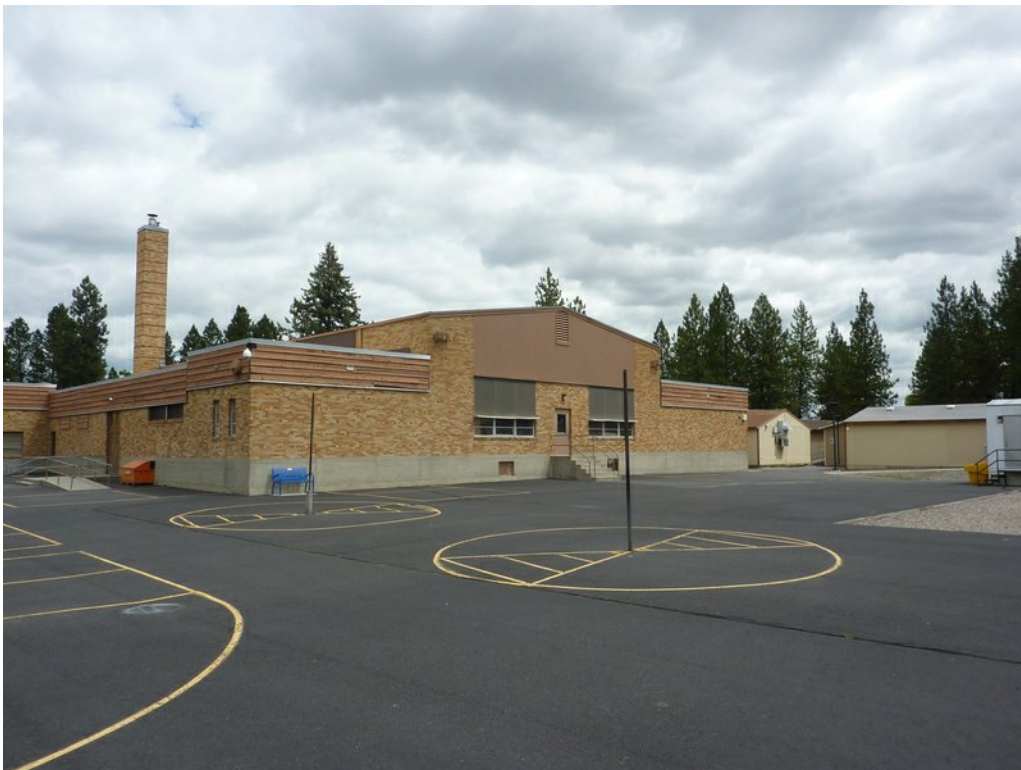
**Figure 1-6. South and west faces of east wing. Large URM chimney visible to left.**

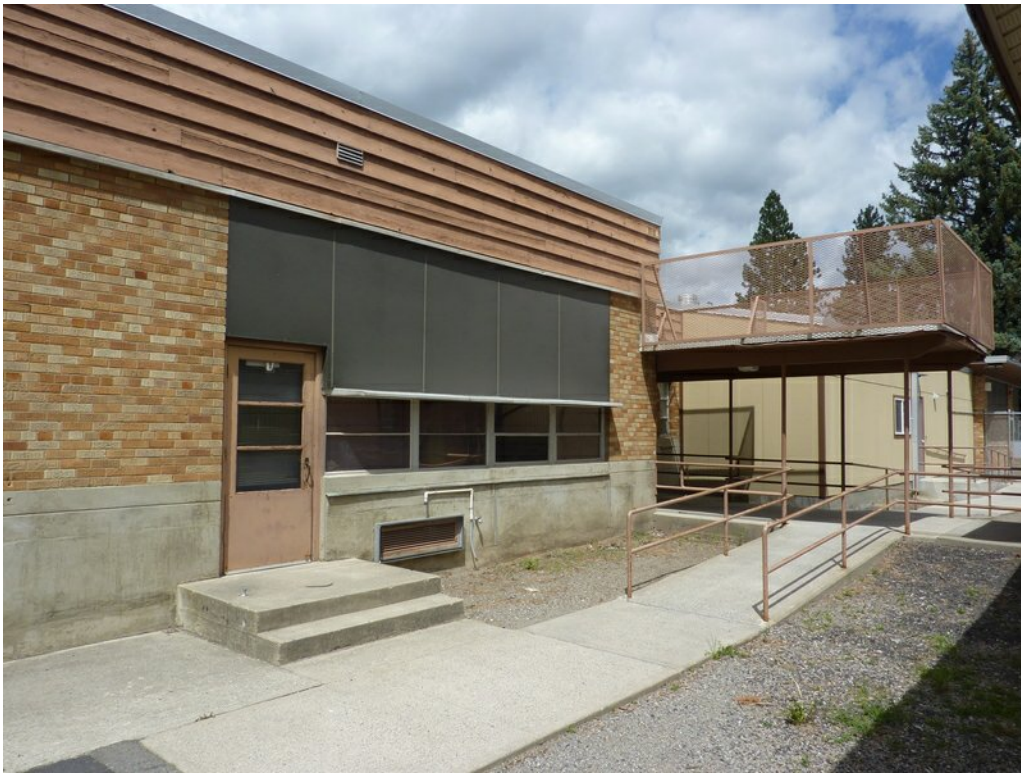
**Figure 1-7. East side of east wing. Visible is canopy over exit door, as well as the kitchen addition (tan) built in 2016 or 2017. Library with eyebrow roof visible on far right side of picture.**

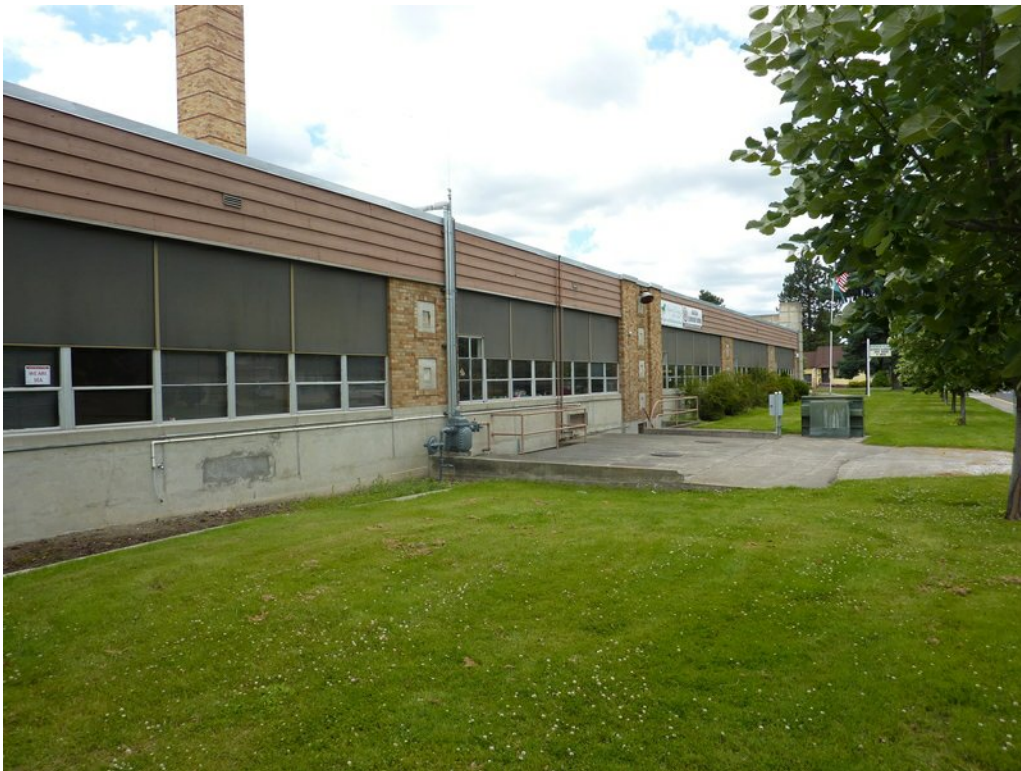
**Figure 1-8. North face of building. Boiler room below classroom at driveway. Concrete wall at entry visible on the far right.**

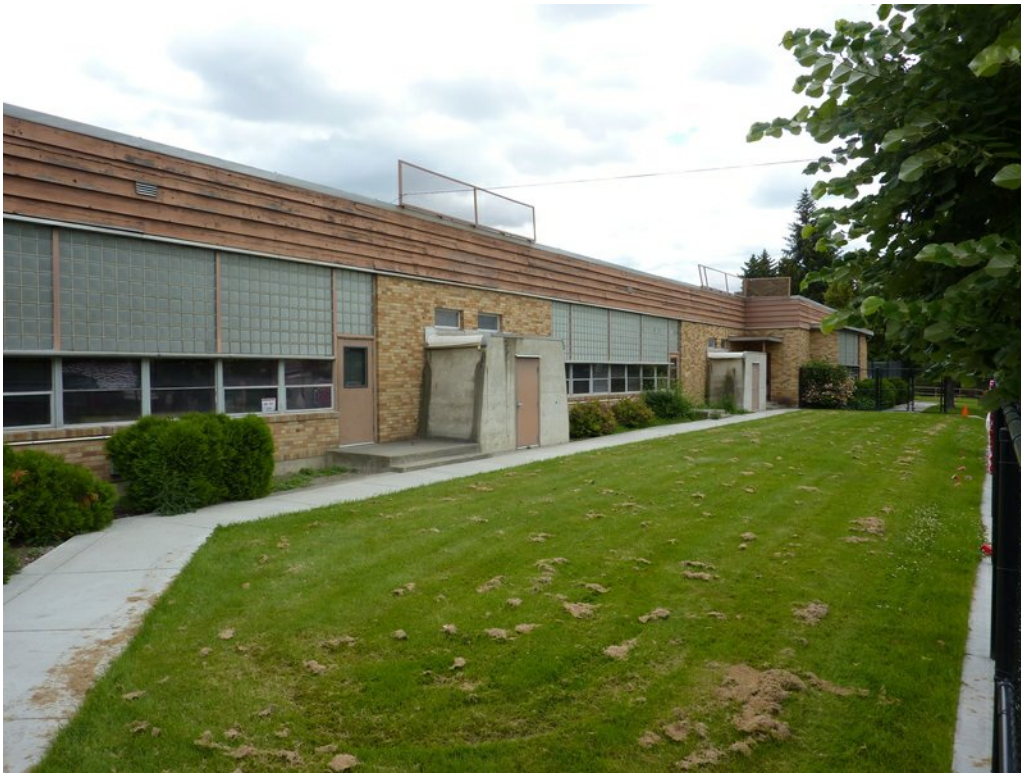
**Figure 1-9. West face of west wing. Concrete exterior "toy houses" have concrete walls and a 2x4 roof. The units are connected to the building on the back side. The units are original to the building.**
